## On-line inspection of sealing compound in covering lid

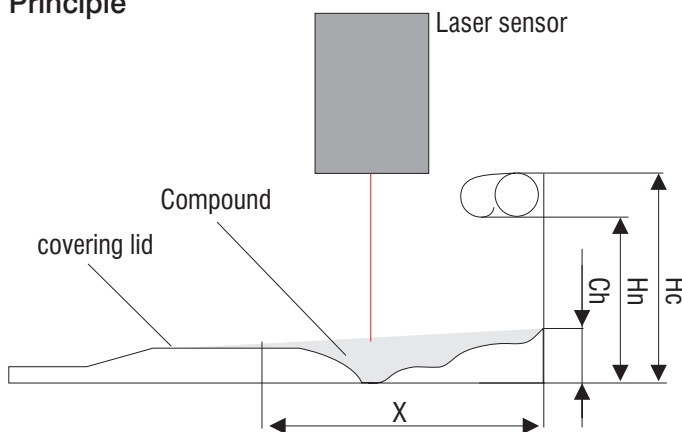
### Principle

After injection of the sealing compound in the covering lid, curing takes place in the tunnel furnace. Here, fault points and faulty thicknesses of compound must be acquired and faulty lids must be sorted out in the production process. A laser-based optical displacement measurement system samples the compound surface of the rotating lid for a quality inspection. The monitoring of the thickness contour within the permissible tolerance limits and the sorting of the faulty lids occurs with the aid of the PLC that is employed.

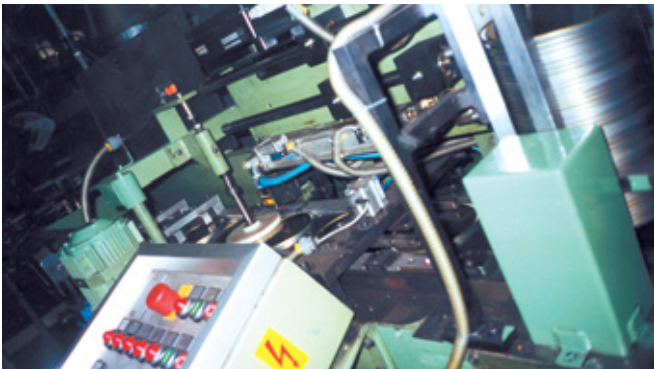
### Measuring system setup: LD1605-2

- Accurate, fast and reliable.
- Small light spot diameter.
- Non-contacting and therefore wear-free.
- Laser Protection Class 2.
